Re: Site Visit to Fisher House, Tunbeck Close, Wortwell, Norfolk IP20 OHS

I visited this house on 7th June 2021 to assess its structural elements regarding the installation of the straw. Numbers in brackets refer to photo numbers.

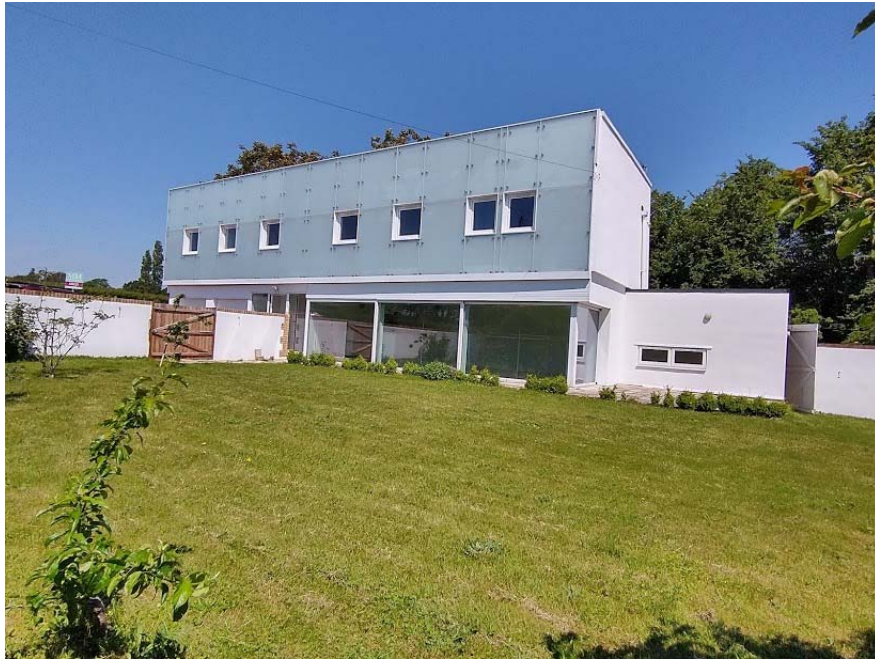
This is a modern 2 storey steel frame construction with straw infill to 3 sides (1). The front face appears to be constructed of concrete block, covered with a membrane, then an airgap and Perspex type panels (2). It has an attached garage on the west of blockwork with a first floor above, and an attached single storey room and shed on the east side ground floor, also of blockwork.

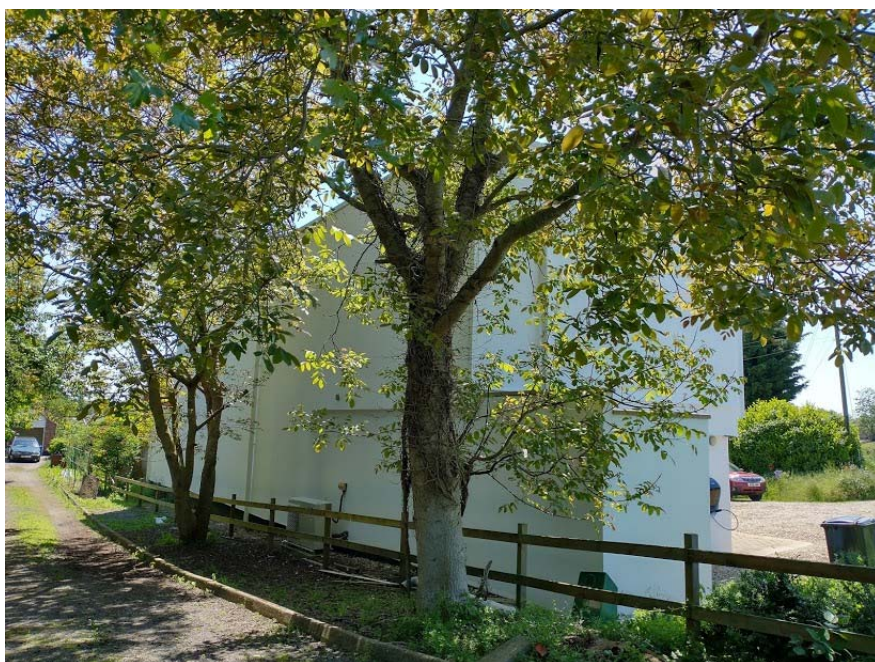
The straw walls externally extend to the ground floor at the rear (3) but begin on the first floor on the east (4) and west (5). They are clad with a light timber frame and a Heraklith board with a render stop and plastered with lime (6). The garage housed empty lime and silicate paint (7) that suggests the correct breathable materials have been used for plaster and decoration.

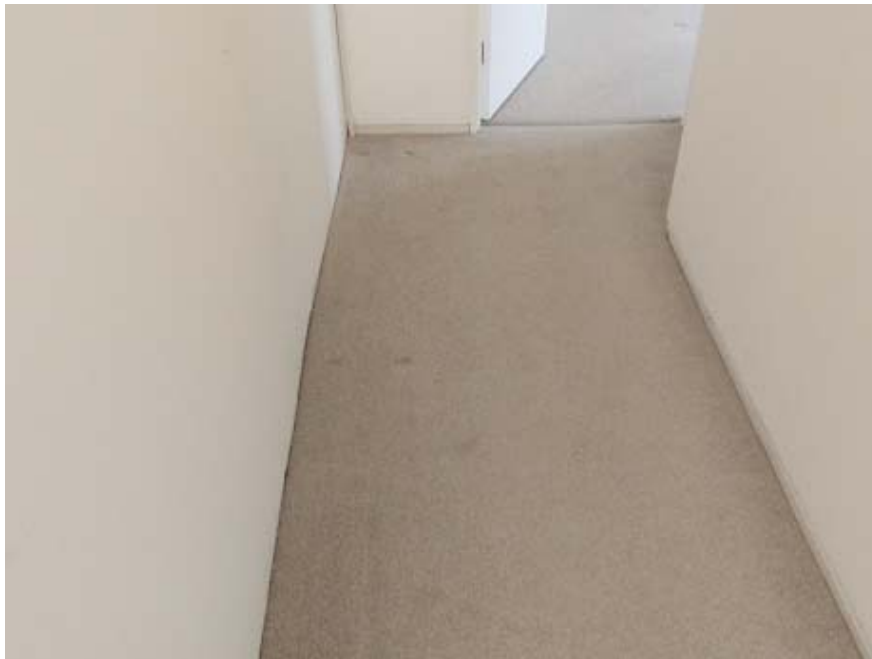
The internal finish appears to be of plasterboard on a steel (possibly timber) frame in front of the straw. The upper floor is chipboard and the upper corridor narrows for some reason at one end (8). Windows are uPVC. Staircase is with natural timber (not regular) treads (9).

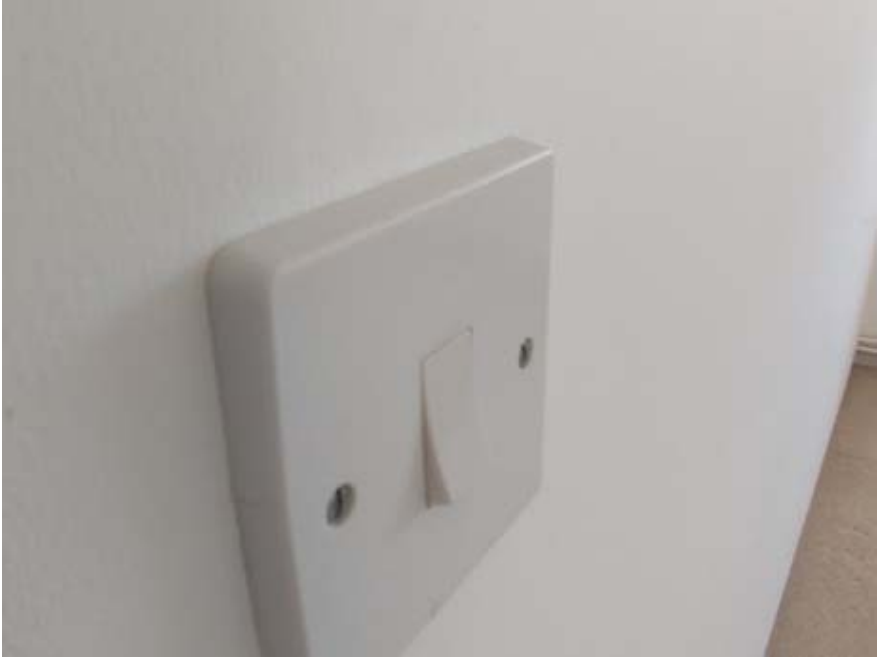
It appears to be at least in parts a self-build, evidenced by poor execution of several elements such as:

- Cracked light switch (10)
- No skirting boards to the rear wall (11)
- Various holes (12)
- Unfinished areas (13)
- No splashback tiling in bathrooms (14)
- Vinyl flooring instead of tiles (15)
- Poorly painted (16)
- Taps not fixed tight
- Windows poorly sealed (17)
- Taping over joints on roof (18)

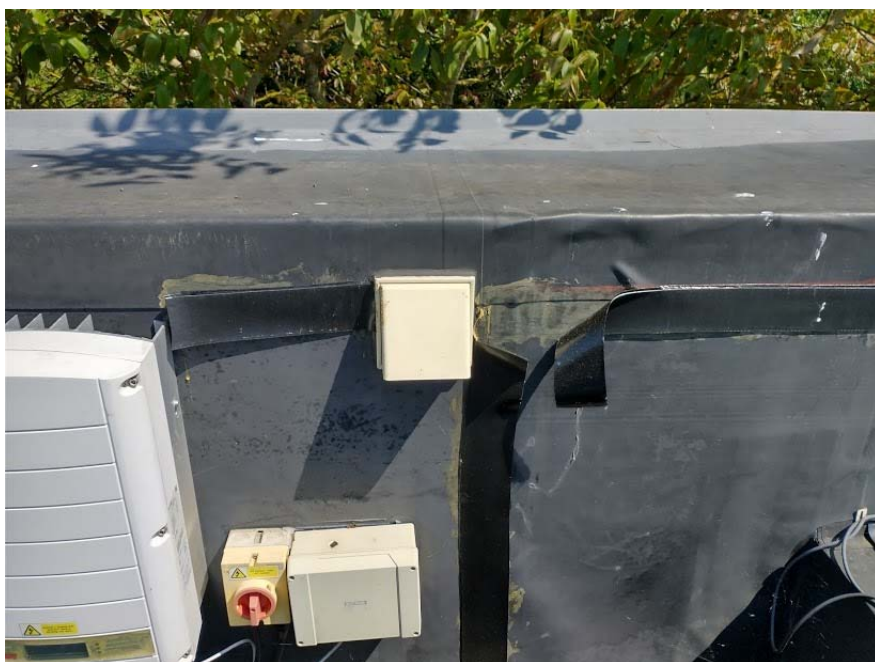
The roof appears to be watertight although there is plenty of evidence that the secondary taping of joints is failing, and the falls to outlets may not be working as efficiently as could be wished (video). Clearly water pools in the roof well, as evidenced by piles of leaves in some corners (19). The roof was creaking in places indicating movement in the roof joists.

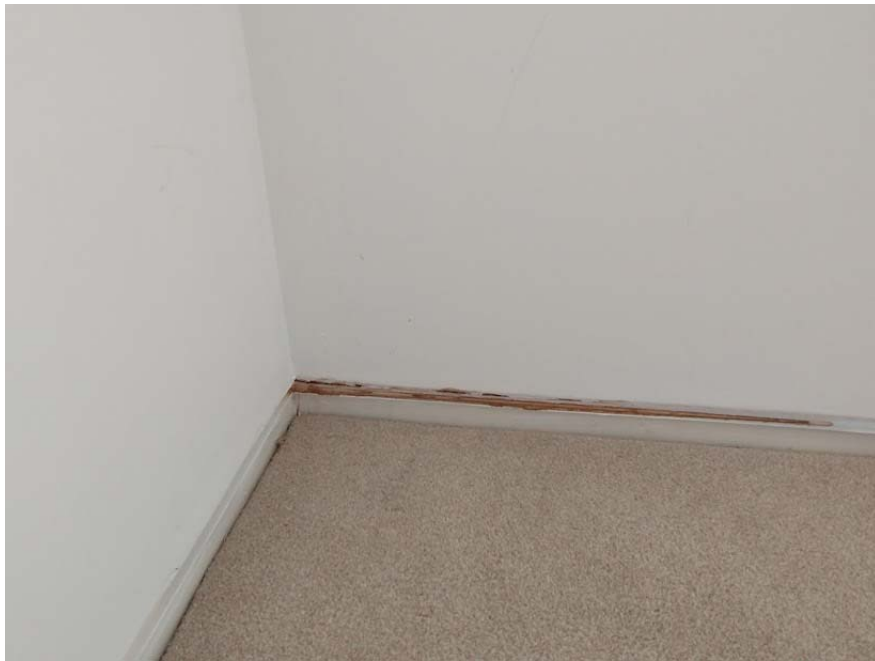
There were signs of water ingress in the South East corner of the bedroom (20). This is at or near the junction between the masonry front wall and the straw infill side. There was no obvious means of ingress, and at the time of visiting all was dry.

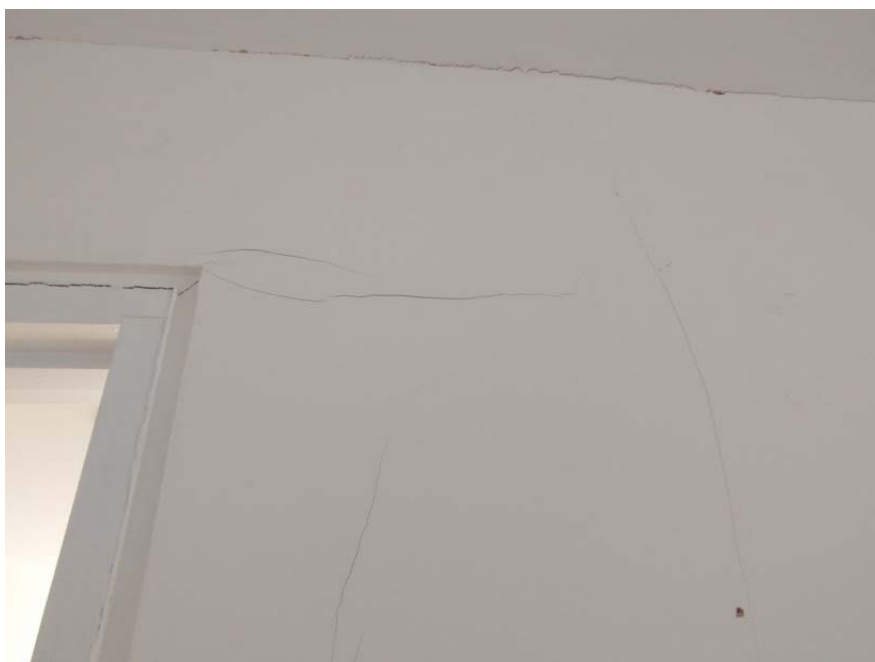
There is some cracking in one of the bedrooms in the masonry partition wall (21) suggesting settlement, but this is likely to have stopped now. There is also evidence of cracking/movement in the rear wall internal plasterboard but this does not appear to be serious. No obvious signs of cracking/movement in external walls was observed.
